# OUTDOOR WIRELESS PROJECT

University of Colorado Colorado Springs

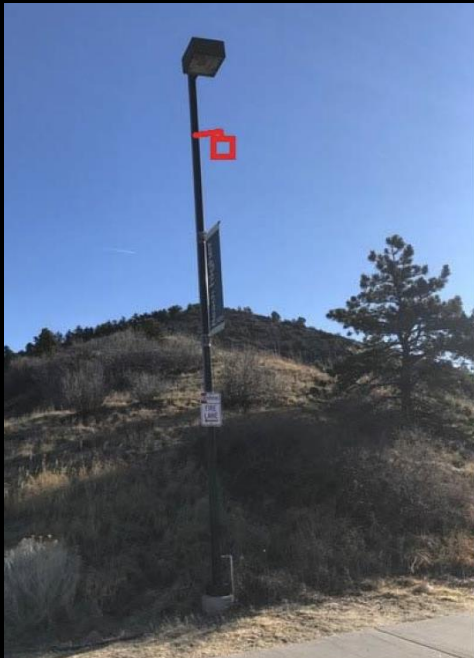
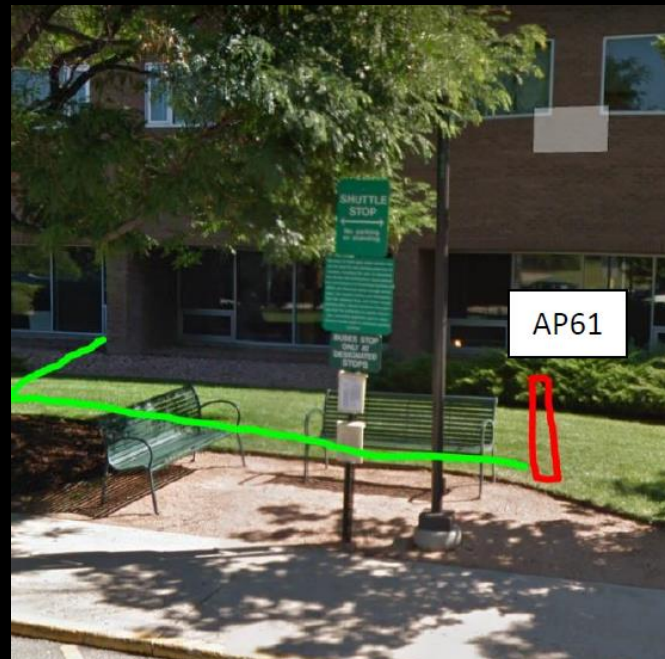
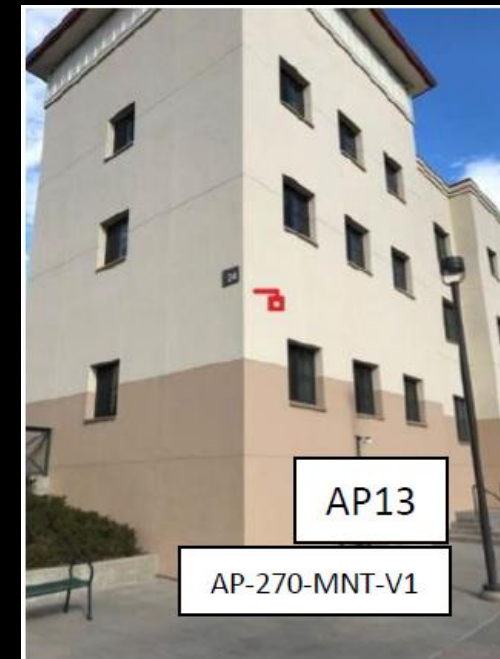
- 10 Light Pole mounts
- 6 Bollards
- 24 Building mounts

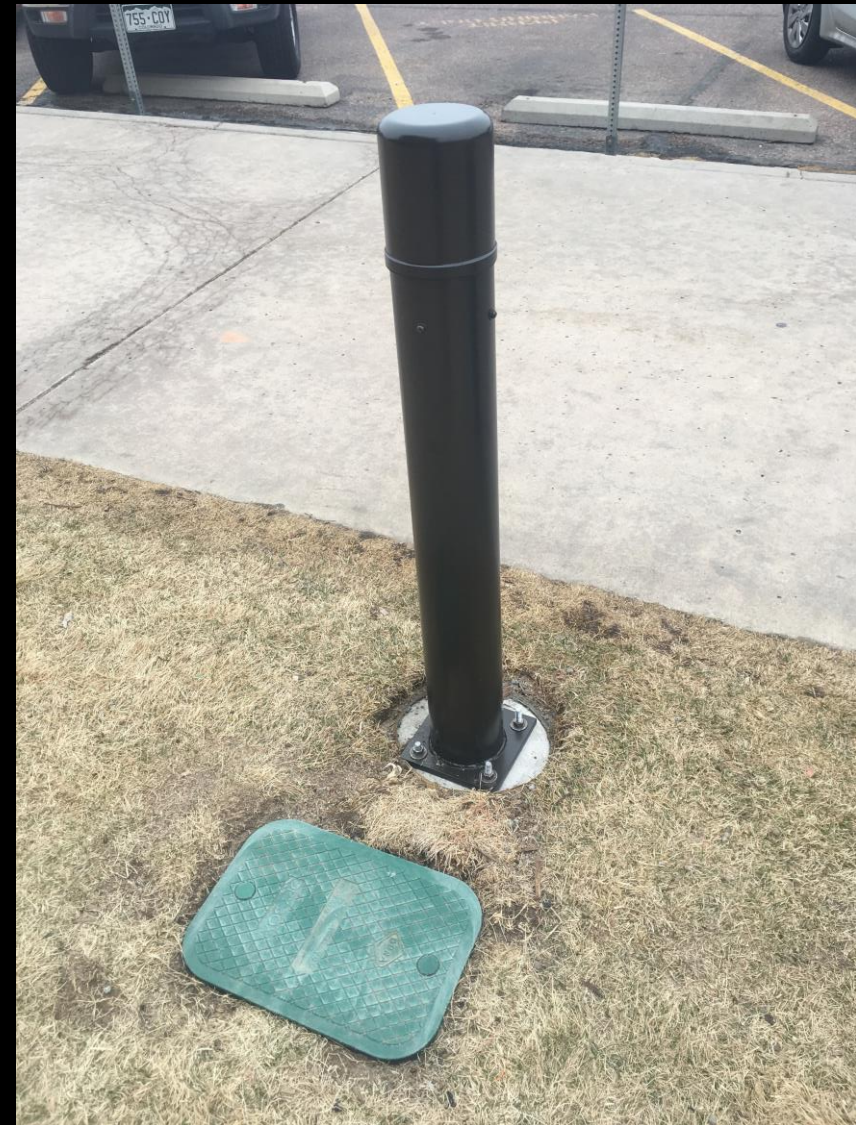
- Custom solution was needed
  - We needed a 6-7" wide pipe
  - Which meant AP couldn't go inside
  - Pipe had to accommodate our antenna
  - Antenna needed to work with our AP
  - AP needed to handle cold weather
  - Dry box located adjacent to bollard to enclose....
    - AP
    - Antenna cables
    - Lightening Suppressors
    - Grounding rod and grounding wires

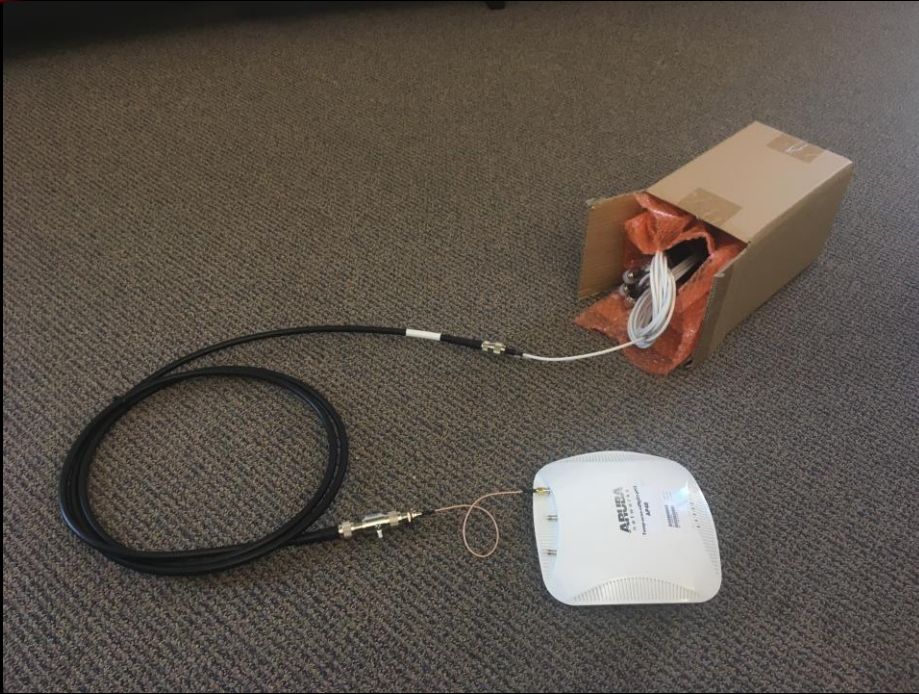
- Temp setup until we migrate to AOS8
  - AP-224
  - Not outdoor-rated, but we had spares and hoped the dryboxes would help.

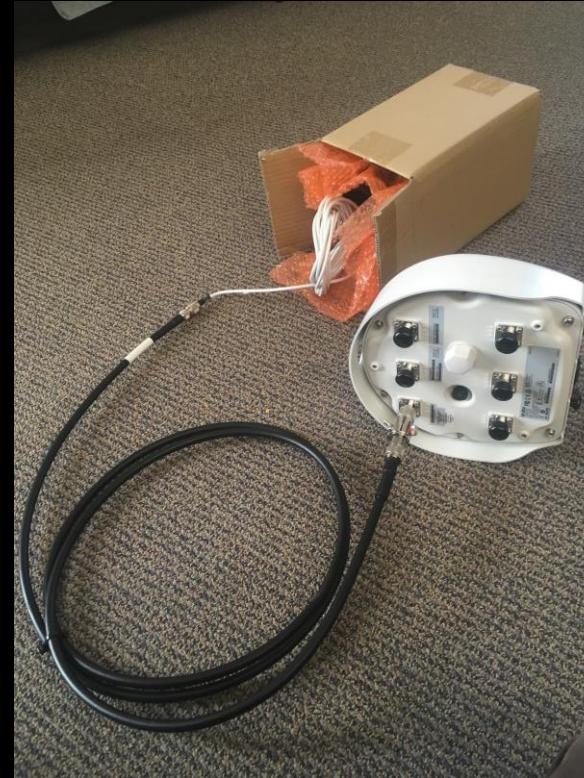
- Long term solution once upgraded to AOS8
  - AP-374
  - Outdoor rated

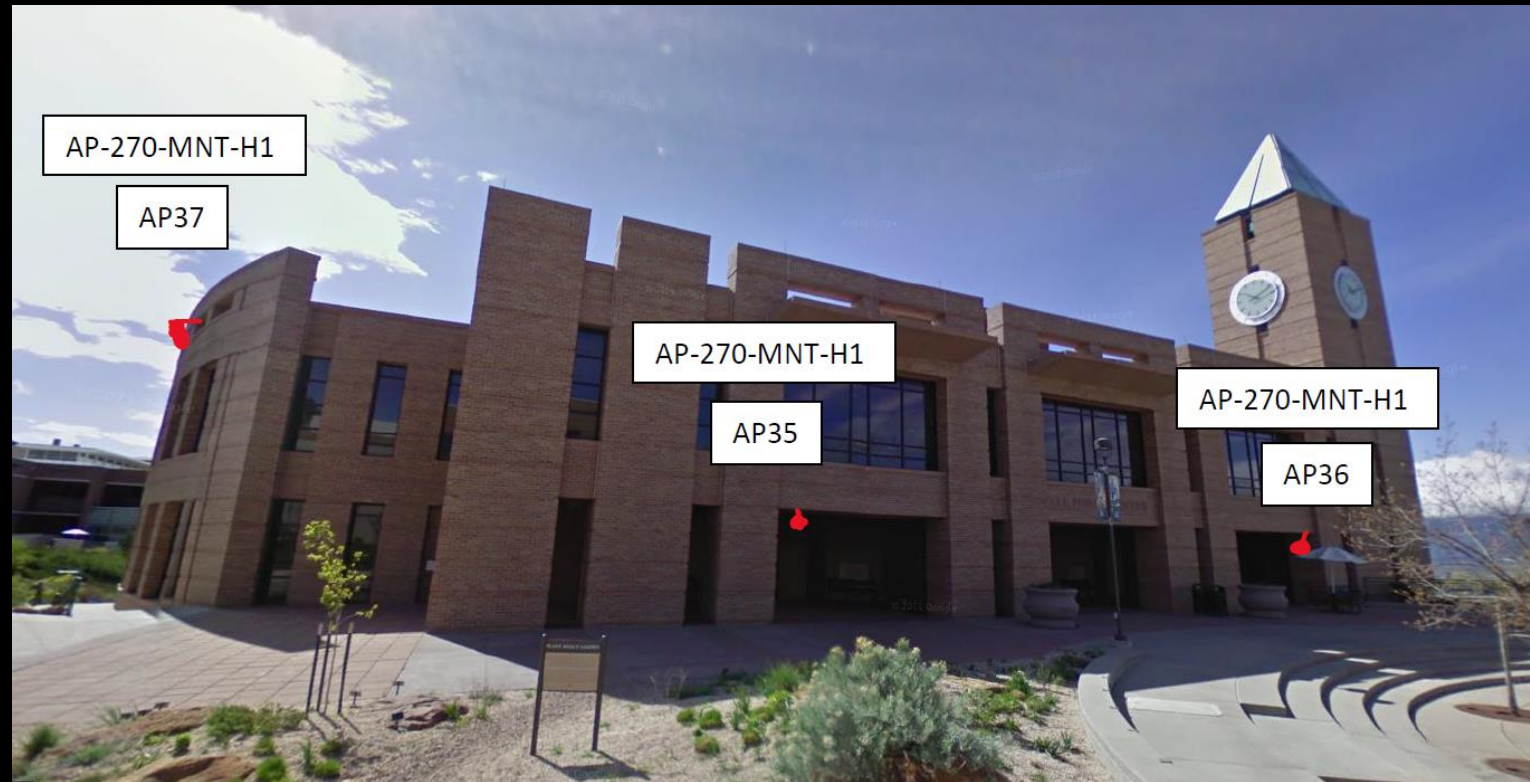
- Had to coordinate access from inside
- Where does the penetration align?
- Hard lid and hatch access for some areas
- Roof access for others

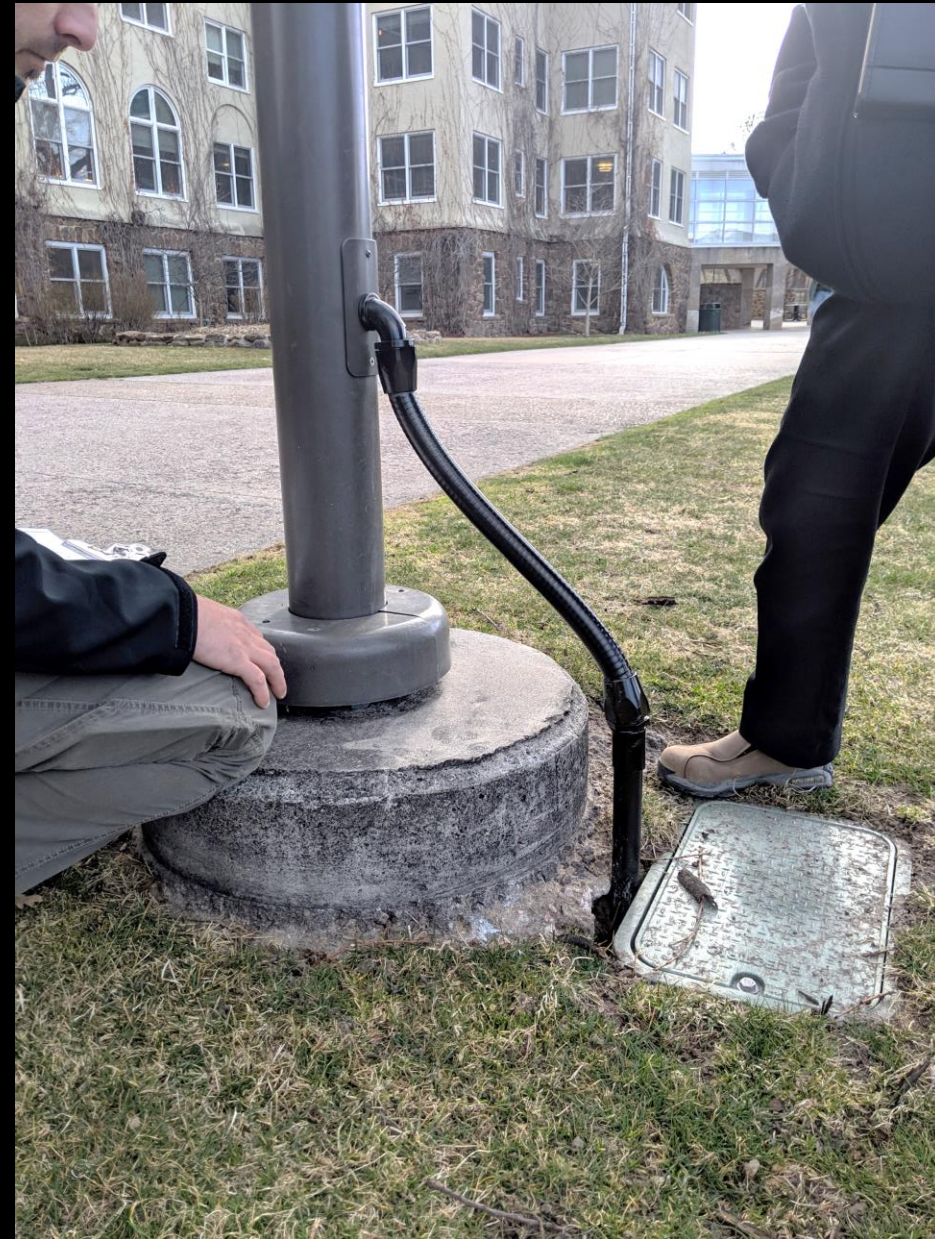
- **Poles**
  - Getting cabling into the existing poles
  - Trenching and boring in high traffic areas
